Name Of Dam: UPPER CLINCH WATERSHED DAM NO. 8

Location: TAZEWELL COUNTY, VIRGINIA

PHASE I INSPECTION REPORT

NATIONAL DAM SAFETY PROGRAM

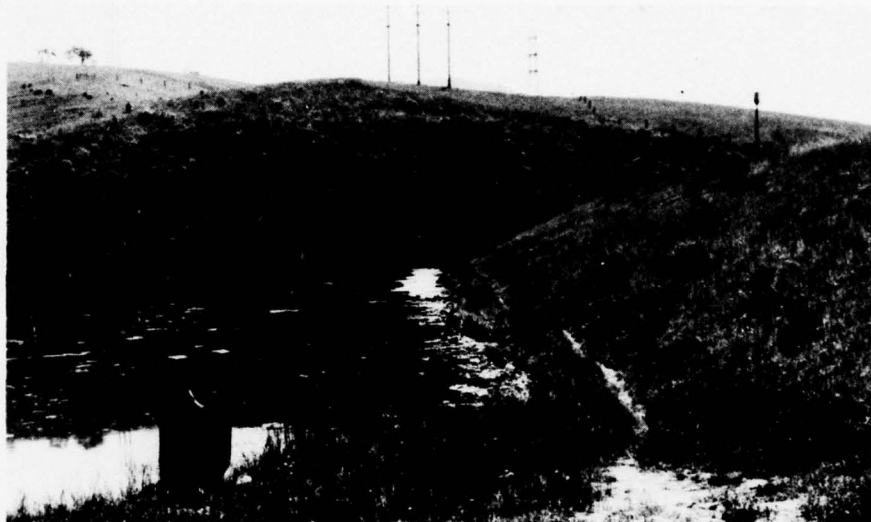
VIEW FROM EMERGENCY SPILLWAY - NOTE RIPRAP AT WATERLINE

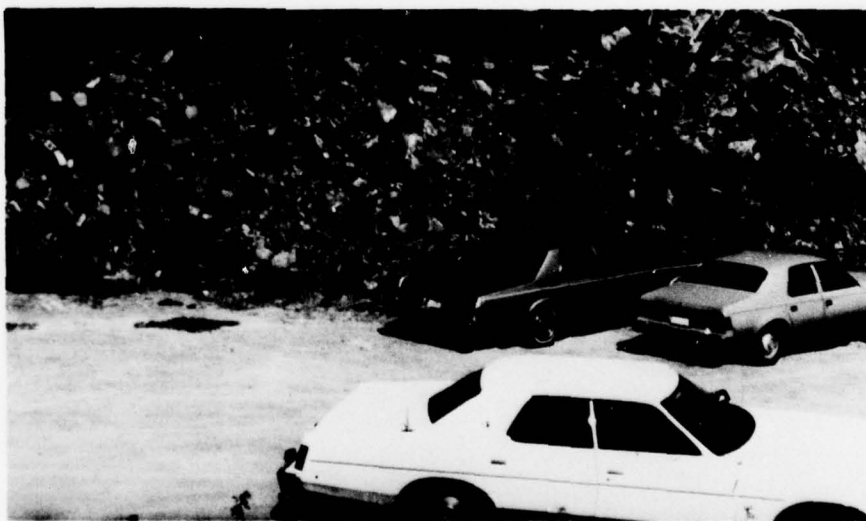
VIEW OF RIGHT SIDE OF EMERGENCY SPILLWAY

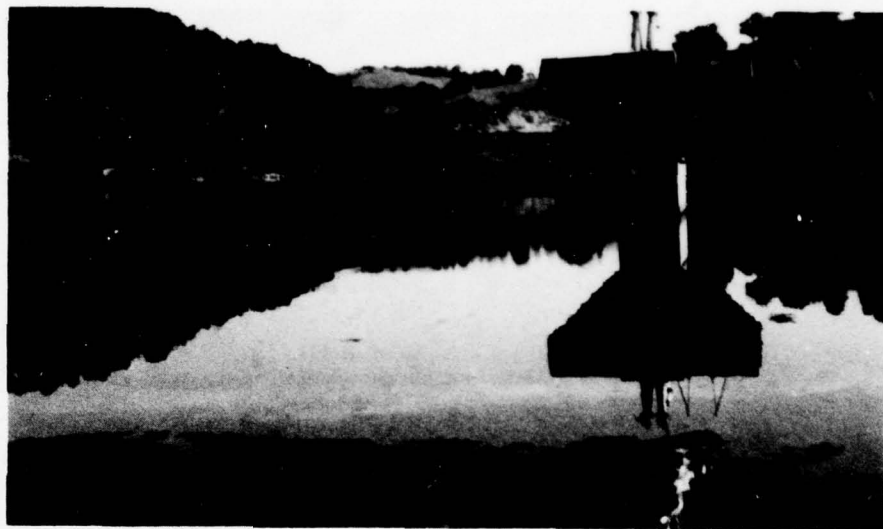
3.2 Evaluation: The visual inspection revealed no significant deficiencies in the dam, its appurtenant structures, the reservoir or the downstream areas. However, the operating wheels were not found on the gate riser stems.

7.1 Dam Assessment: There were no observed critical signs of distress or instability of the dam or its appurtenant structures. The spillway is capable of passing the PMF and is considered adequate. The gates at the inlet structure have not been operated regularly nor recently.

VIEW OF INTAKE RISER FROM DAM

7.2 Recommendations/Remedial Measures: It is recommended that the drawdown and water-supply gates of the principal spillway inlet be made operable. It should be verified within three months that the intake gates are operable. At the same time, a procedure for gate operation should be developed in consultation with the SCS and placed on file. It is recommended that the gate operating wheels be placed on the gate stems and connected with chains and padlock to prevent unauthorized operation. The gates should be inspected annually.
